RESIDENTIAL INSPECTION

400 Wood Thrush Run
Kyle, TX 78640

PROPERTY INSPECTION REPORT FORM

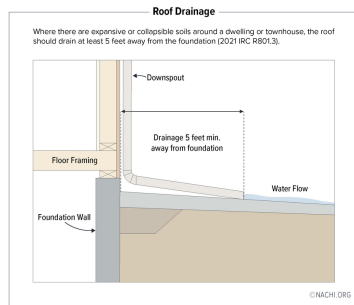
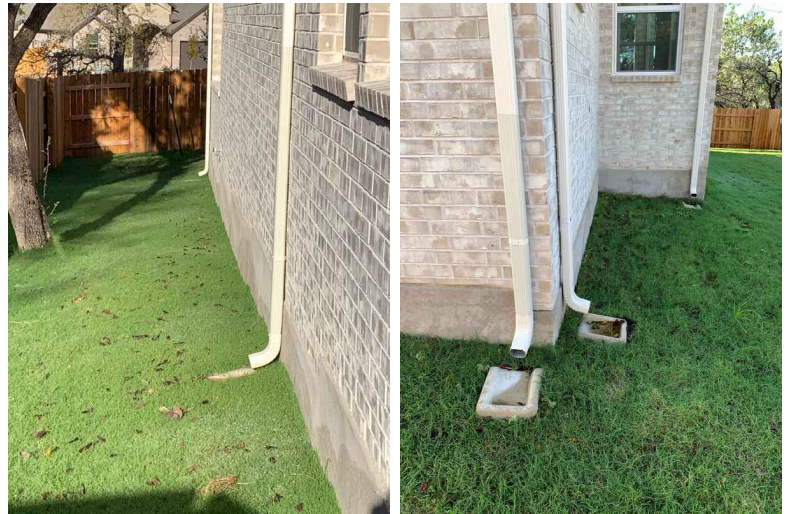
1: Downspouts draining near the foundation

There are one or more gutter downspouts draining near the foundation. The downspouts should be extended to help divert drainage 5 feet away from the house.

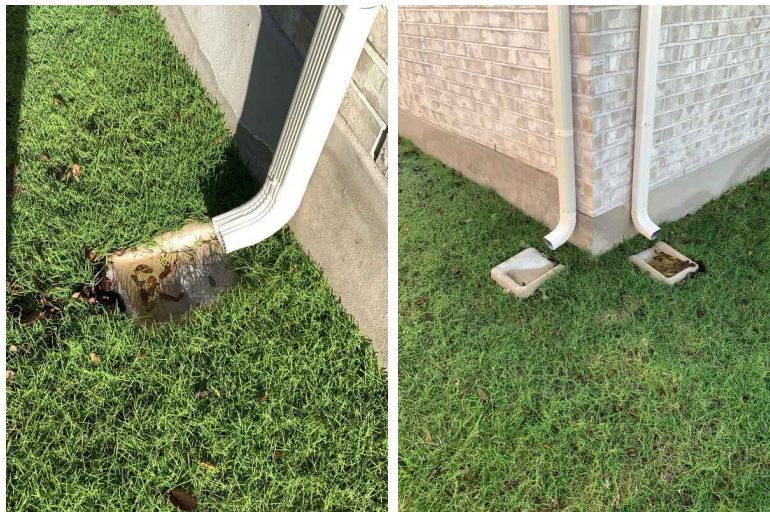
2: Splash blocks backwards

There are one or more splash blocks at the gutter downspouts that are improperly installed. The splash blocks should have the open end away from the downspout to ensure drainage is directed away from the foundation.

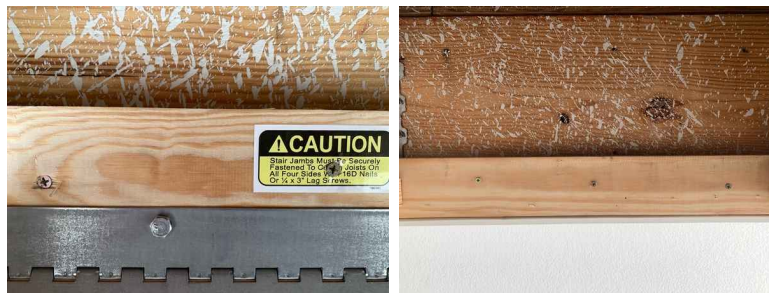
1: Attic Ladder / Attic Access Needs Repair

The attic ladder has one or more deficiencies. Repair for Safe operation.

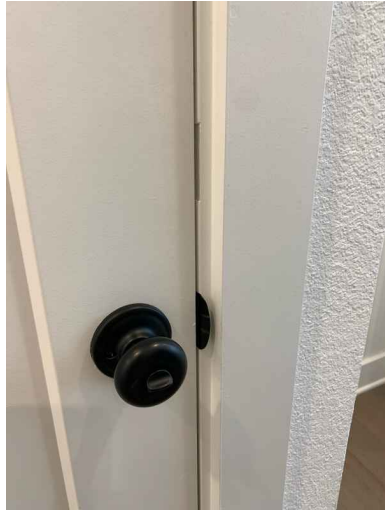
The garage door is missing a deadbolt, although the frame is notched to accommodate one. It is recommended to have a deadbolt installed in the garage door to enhance security and ensure the door functions as intended.

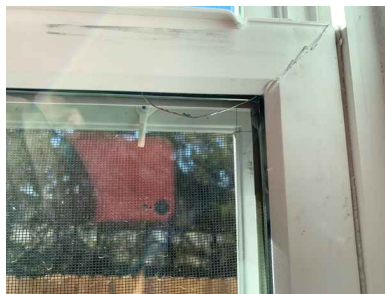
Dining Area

The window glazing/glass is cracked or broken in one or more locations. Repair or replacement is advised.

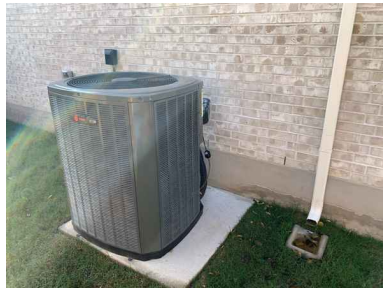
Right Side of Garage

1: Condenser out of level

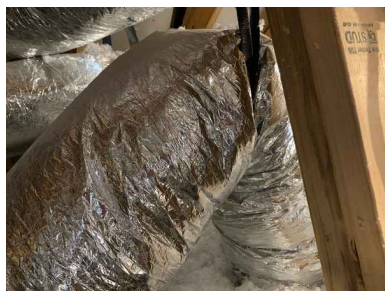
Various ducts (in the attic) were reduced in diameter (i.e. crimps, sagging, strapping, sharp bends, etc.) which can restrict air flow. Flex ducts should be supported at intervals no greater than 4'. The maximum permissible sag is 1/2" per foot of spacing between supports. An HVAC contractor can be retained for remedial action.
