RESIDENTIAL INSPECTION

1206 Canyon Edge Dr
Austin, TX 78733

PROPERTY INSPECTION REPORT FORM

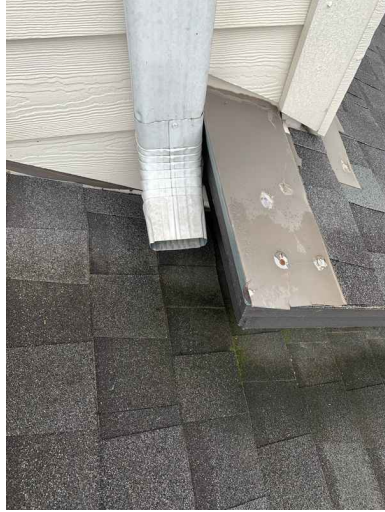
3: Loose gutter fasteners

There are one or more loose gutter fasteners. The gutters should be securely fastened to the structure to ensure proper performance.

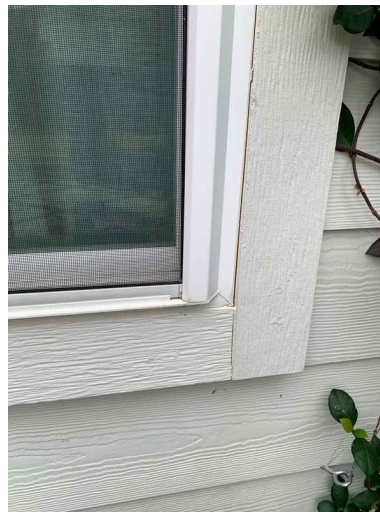
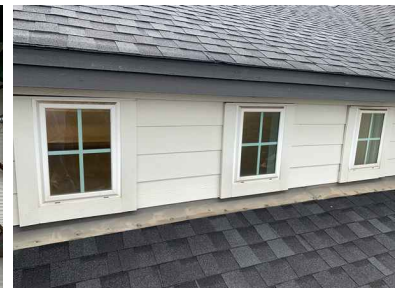
A window frame weep hole cover is missing from one or more windows. The covers are designed to open and release water that may enter the frame and close to prevent air and/or moisture from entering through the hole. The cover should be replaced to prevent moisture and/or air from entering in that area.

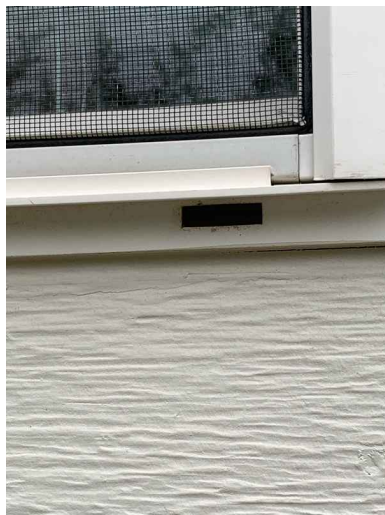
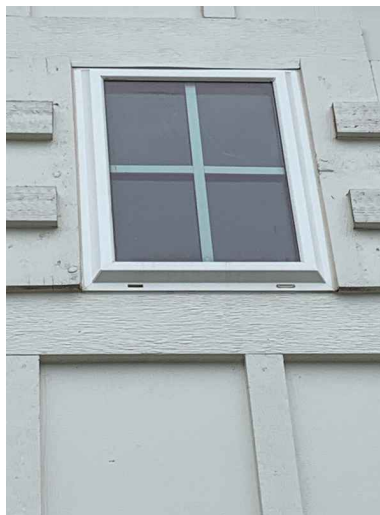
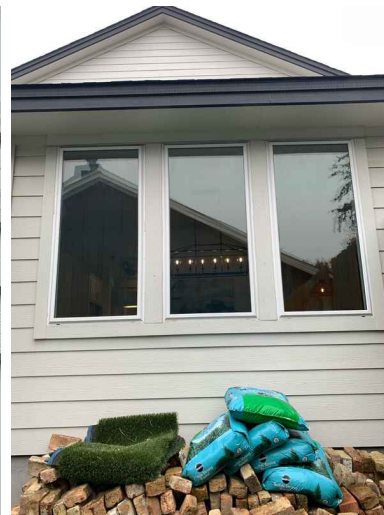
**2: Exterior window deteriorated caulk joint**

There are separated caulk joints around the exterior window frames at one or more locations. This may indicate settling and/or seasonal movement in those areas. The caulk should be touched up or replaced to exclude pests and moisture from those areas. Where deteriorating caulk is noted it should be assumed that some moisture penetration has occurred and that some hidden damage may be present.

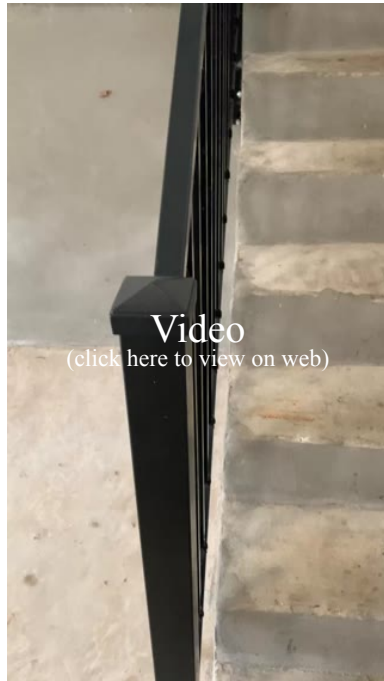
The stairway handrail is loose. This could pose a safety hazard. Recommend a qualified handyman evaluate and fasten.

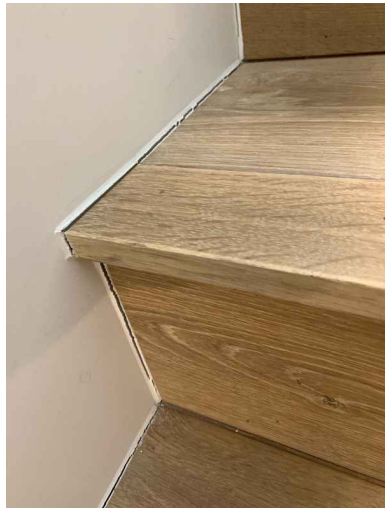
2: Stair Skirt Board

The caulking along the stair skirt board, where it meets the treads and risers, is cracked. This may allow dirt, moisture, or debris to accumulate, potentially leading to further deterioration of the surrounding materials.

Remove the damaged caulking and apply a new bead of flexible, paintable caulk designed for interior trim. Ensure all gaps are properly sealed to maintain a clean appearance and protect against moisture intrusion. Paint the caulk as needed to match the existing finish.

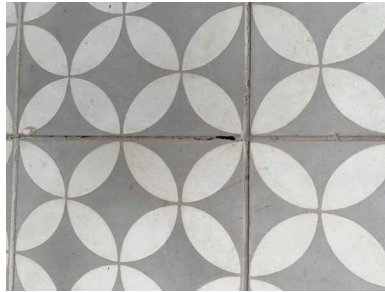
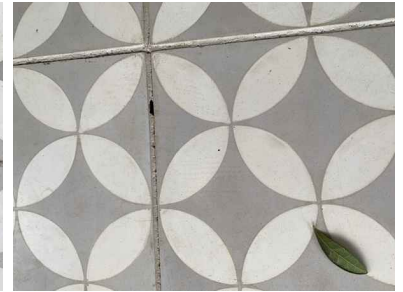
The grout on the outdoor patio tiles is deteriorating, with visible cracks and missing sections. This condition may allow water to penetrate beneath the tiles, potentially causing loosening or damage to the substrate over time. Recommend having a qualified contractor re-grout the affected areas to restore water resistance and prevent further damage.

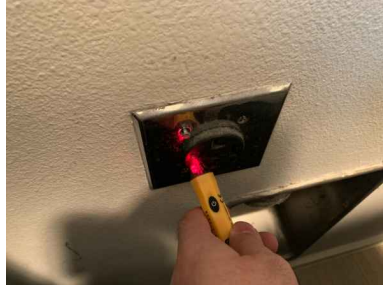
1: Smoke alarms missing in required areas

There are no smoke alarms in one or more required areas. Smoke alarms should be installed in accordance with current standards, as follows: 2012 International Residential Code R314.3 Location. Smoke alarms shall be installed in the following locations: 1. In each sleeping room. 2. Outside each separate sleeping area in the immediate vicinity of the bedrooms. 3. On each additional story of the dwelling, including basements and habitable attics but not including crawl spaces and uninhabitable attics. In dwellings or dwelling units with split levels and without an intervening door between the adjacent levels, a smoke alarm installed on the upper level shall suffice for the adjacent lower level provided that the lower level is less than one full story below the upper level.

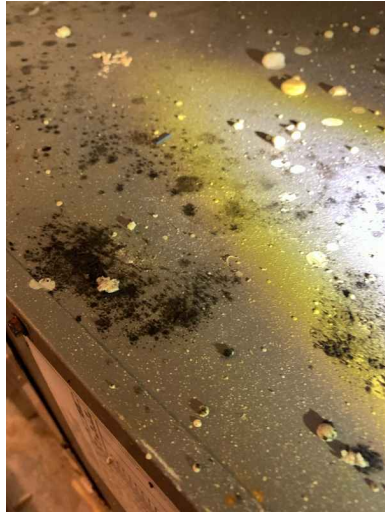
Fungal growth was observed on or within the heating unit. This condition can contribute to poor indoor air quality, pose potential health risks to occupants, and may indicate the presence of excessive moisture or inadequate maintenance.

Recommend Consulting a qualified HVAC technician or indoor air quality specialist to assess the extent of fungal growth, clean and sanitize the affected areas, and determine the root cause of moisture accumulation. Implement corrective actions, such as repairing any moisture issues, improving ventilation, and ensuring the unit is regularly maintained to prevent recurrence.

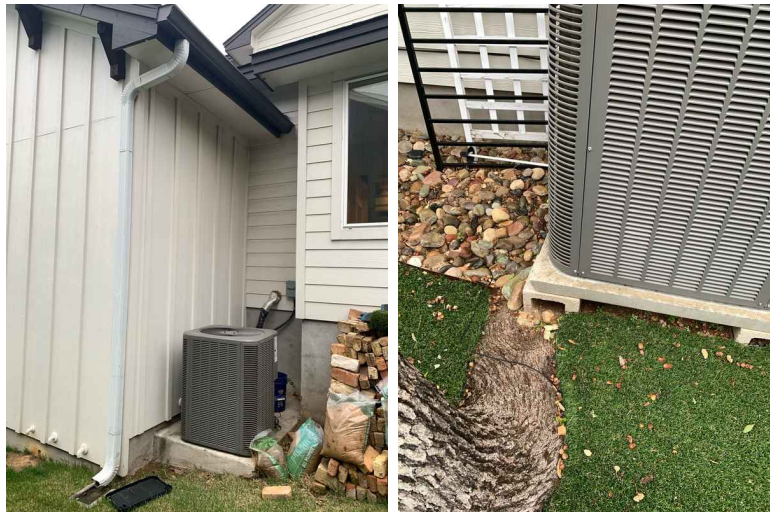
The condenser unit appears to be out of level. This can put strain on the fan motor, prevent proper lubrication of the compressor, and affect system performance. Properly leveling the unit and/or pad is recommended by an HVAC contractor.

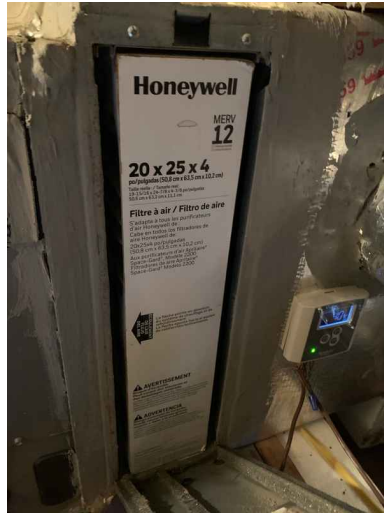
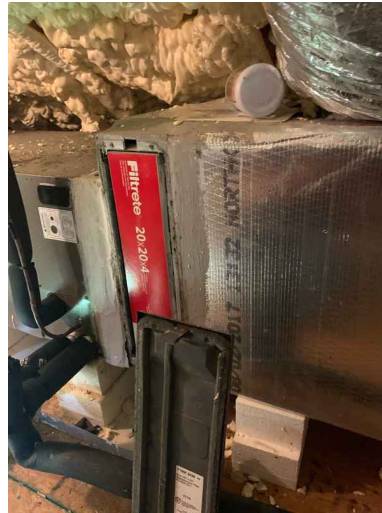
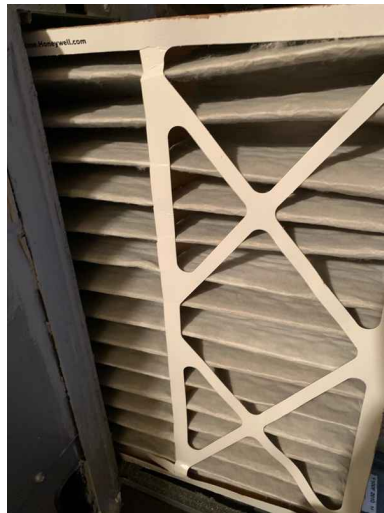
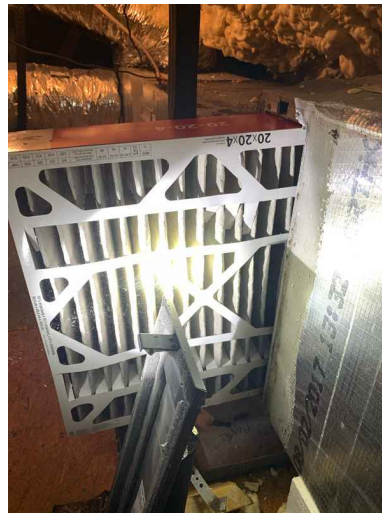
HVAC Filter Width: 4 inch
Filter Condition: Needs Replacement

The supply air temperature was measured at the various registers throughout the house. The temperature was consistent from room to room, indicating adequate air distribution. Additionally, the air ducts were observed from the attic and appeared to be serviceable and properly installed:

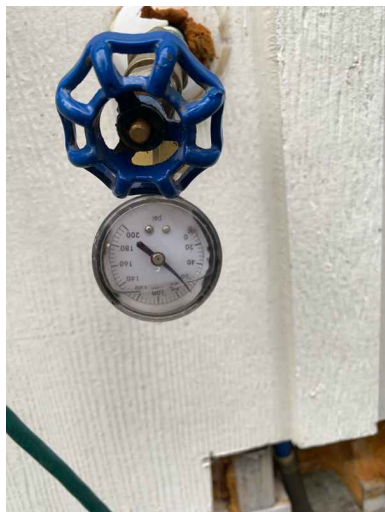
Location of main water supply valve: Near the water meter

Static water pressure reading: 65-70

Types of supply piping material: PEX

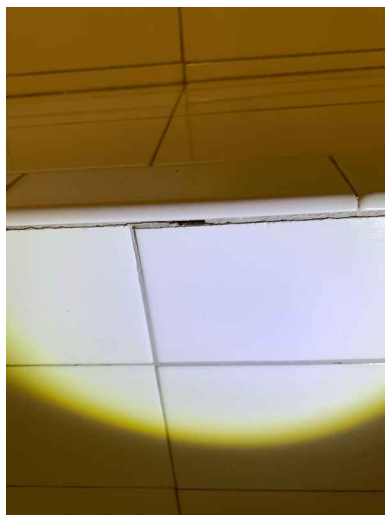
Master Bathroom Shower Bench

There are fractured and/or separated caulk and/or grout joints in the shower enclosure(s). It is beyond the scope of this inspection to determine if moisture penetration has occurred and/or is present in non visible areas, such as behind wall coverings. For a more detailed analysis, a professional tile contractor should be consulted. The joints should be sealed to help prevent moisture penetration in those areas.

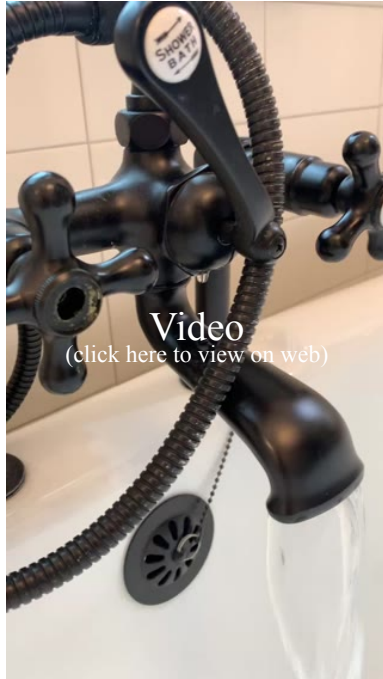
Master Bathroom Tub

One or more plumbing faucets are loose. This could be due to a loose fastener or loose plumbing and could cause a leak if stressed. Further evaluation by a qualified plumber is recommended.

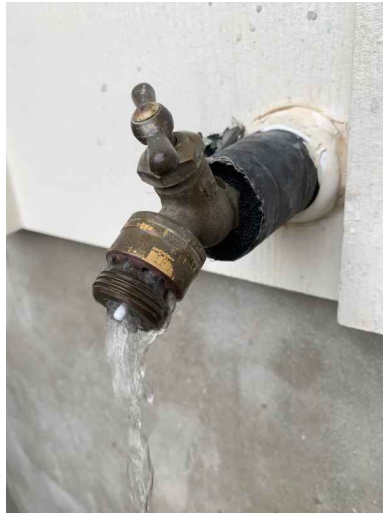
5: Exterior Faucet Damaged

One or more exterior faucets are damaged. As a result, the handle does not operate the valve. Further evaluation and repair by a licensed plumber is advised.

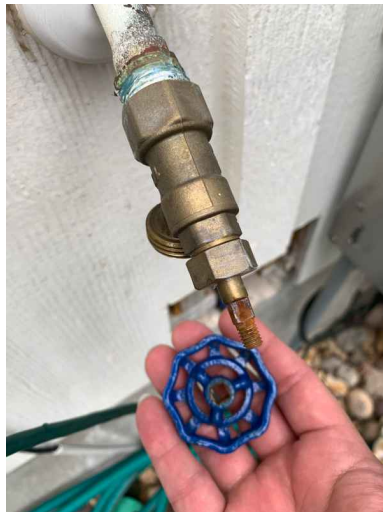
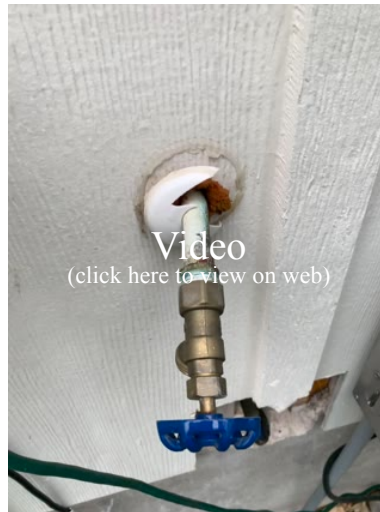
Left Side Hose Bib

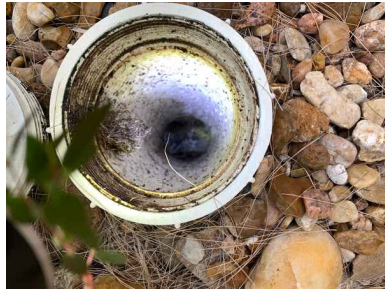
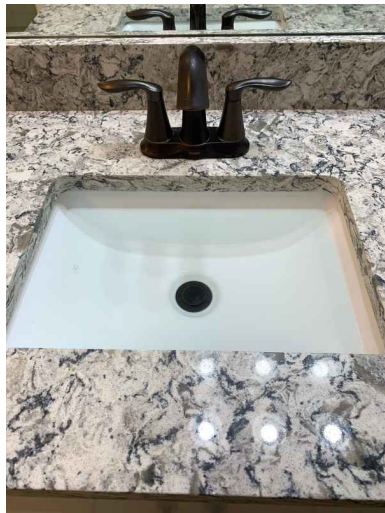
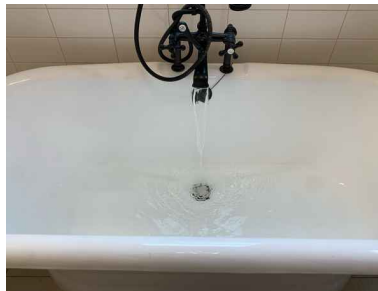
Bathtub/sink drain load test: Yes -

Note: A drain load test was performed by filling all available sinks, bathtubs, and shower pans to a high level.

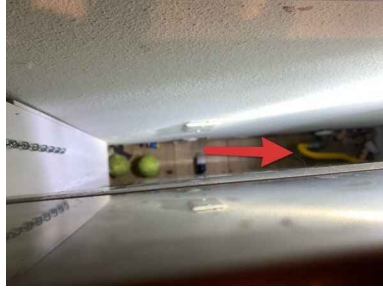
Type of Visible Vent Pipe: Not applicable

Garage Unit Physically Protected: No

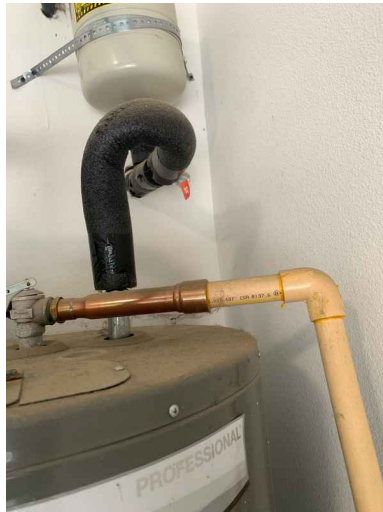
The relief valve drain has an negative slope. The drain should have a positive downward slope throughout to ensure pressure is properly relieved if necessary.

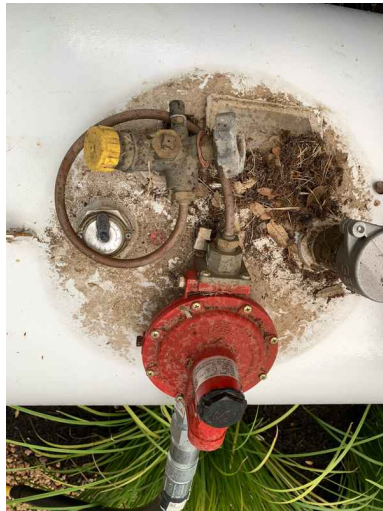
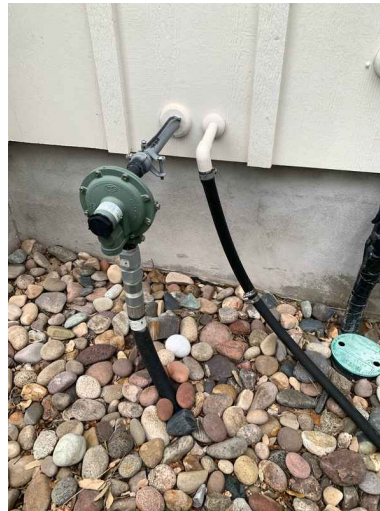
Photos - Gas Meter:

The home is equipped with propane gas. This is common for houses that are located where natural gas cannot be used. The propane tank must be filled periodically. Further information from the seller about any service

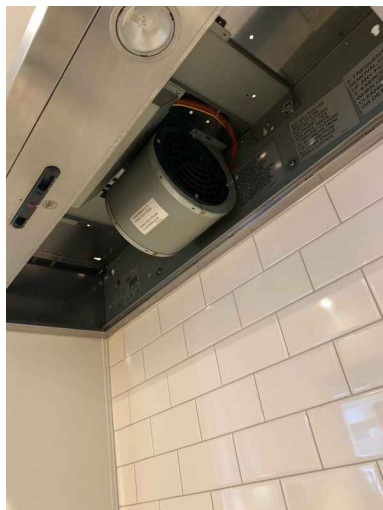
The grease filter is missing. The filter should be installed to protect the fan during operation.

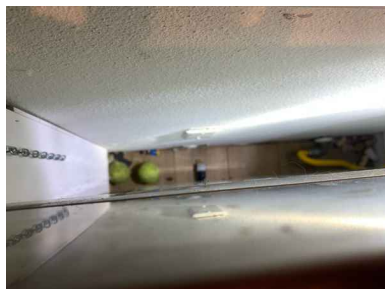
The oven did not activate when tested. Unit was unplugged at the time of inspection. Further evaluation and repair is advised.

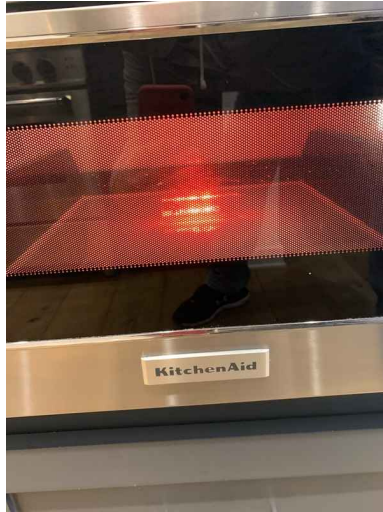
Photo - Microwave Operation:

The microwave oven appeared to operate as intended at the time of the inspection.

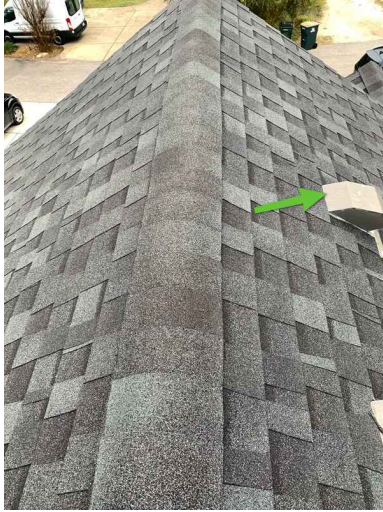
Dryer Vents: : Through Roof
No deficiencies observed:
