RESIDENTIAL INSPECTION

400 Wood Thrush Run
Kyle, TX 78640

PROPERTY INSPECTION REPORT FORM

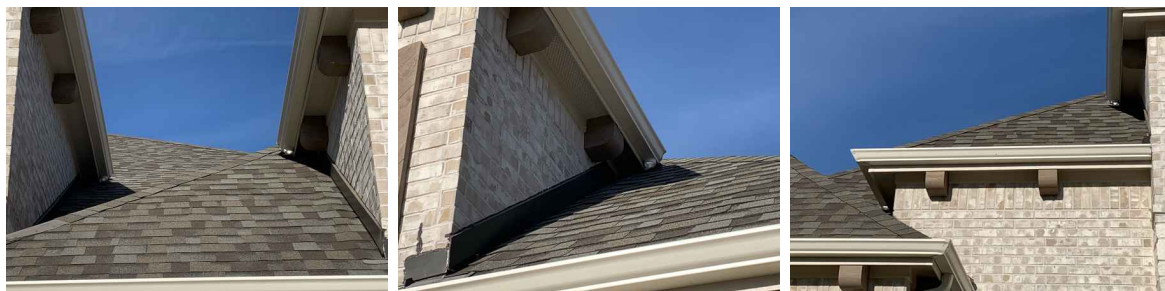
No upper gutters:

The upper level roof drains onto the lower roof at one or more locations. This is very common, but it can reduce the life of roof surface materials below due to large amounts of water frequently flowing over the roof surface. Granules typically are washed off of composition shingles as a result, and leaks may occur. In addition, drainage from the upper level roof will splash off the lower roof surface onto the adjacent walls and windows. This can possibly result in moisture penetration and damage. Installing upper level roof gutters can help to prevent damage in those areas.

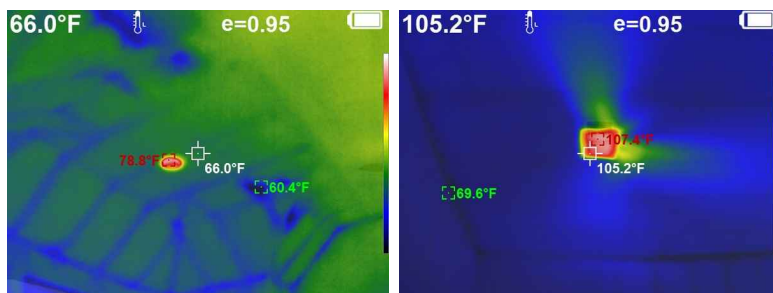
*No deficiencies observed on the ceilings :*

Ceilings all appeared in good working order at the time of inspection.

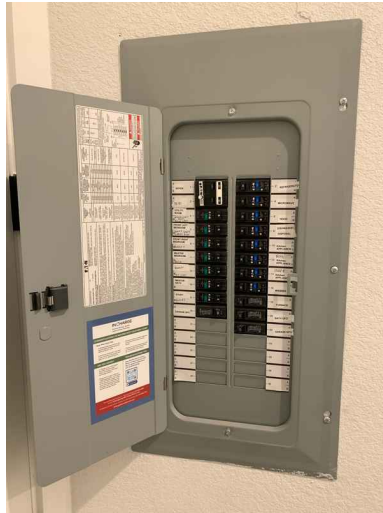
No deficiencies observed at this time:

At the time of the inspection, no deficiencies were observed in the main electrical panel or the sub-panel. Both were found to be in satisfactory condition and functioning as intended.

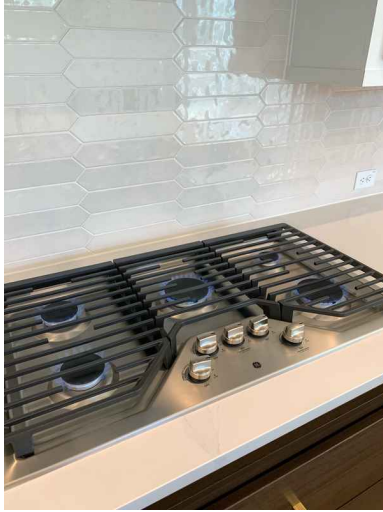
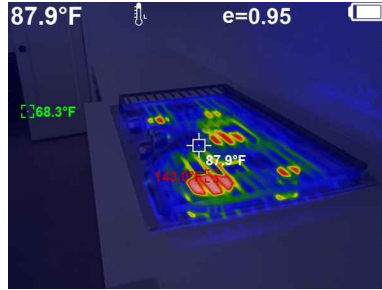
Type of Cook Top: Gas
Gas Shut Off Valve: Present

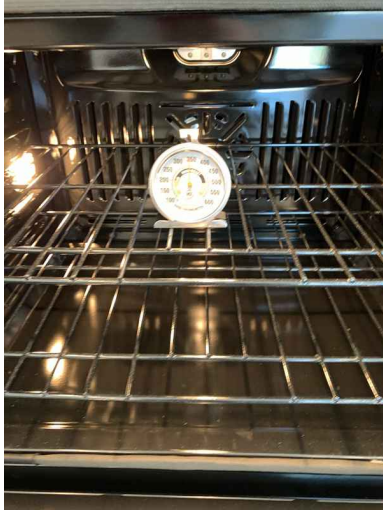
Anti Tip Device: Not applicable

The oven and cook top appeared to operate as intended at the time of the inspection.:

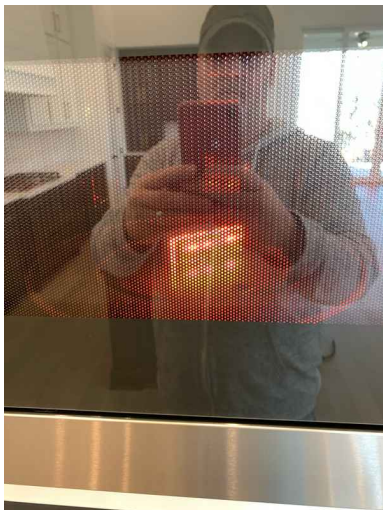
Photo - Microwave Operation:

No deficiencies observed :

The microwave oven appeared to operate as intended at the time of the inspection.
